Synagoge in Przeworsk (Alpha), Zustand 1925, S24, Alpha

The synagogue in Przeworsk, a town in the Carpathian Foreland Voivodeship in south-eastern Poland, was probably built between 1626 and 1629 and rebuilt several times, including in 1927. On September 12, 1939, Nazi troops set fire to the building. After the end of the war, the ruins were demolished.

Variant: 1925 nach Knippschild, Krahé, Schuler

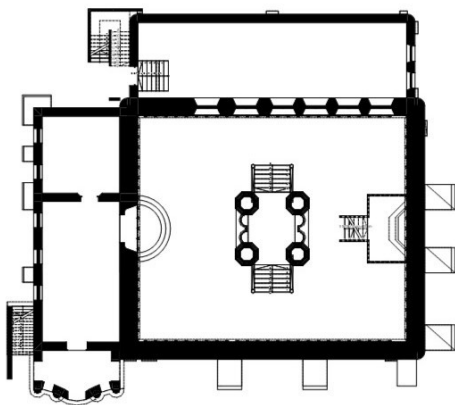
The prayer room, measuring approx. 15 x 18 meters, stretched across the entire width of the building. The square bima was located in the center. The extension to the north, built in 1892, housed the cheder and was connected to the main prayer room, which was located approx. 1m lower, by listening windows. Access was via the extension to the west, which also housed the women's prayer room on the upper floor. The floor plan in the source is not completely rectangular. As this does not affect the appearance of the synagogue, the walls were placed at right angles to each other in the reconstruction.

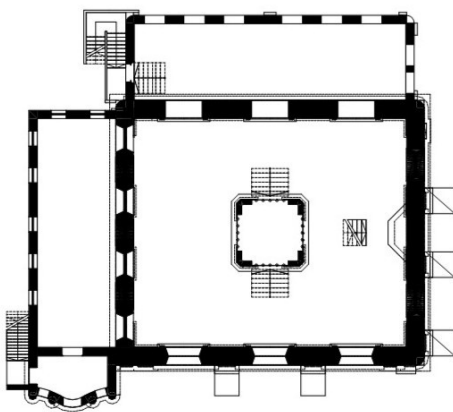
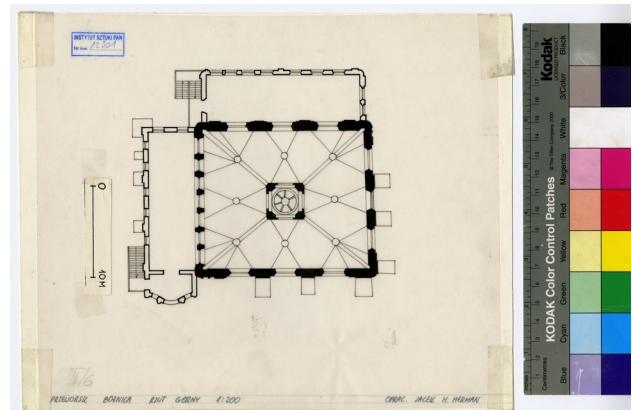
The upper floors of the annexes could be reached via stairs. The vaults consisted of barrel vaults with spigot caps.

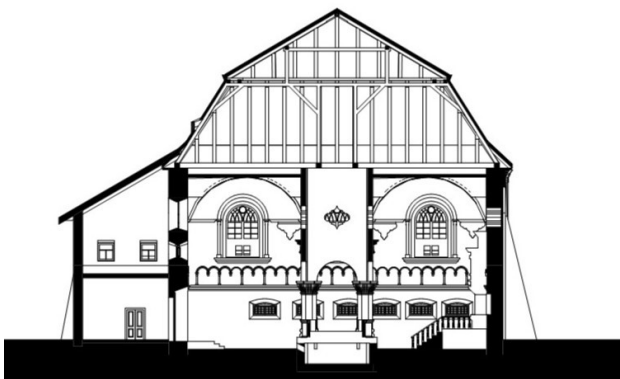
The section through the central axis of the building to the north shows the prayer room with bima and Aron Ha-Kodesh as well as the roof truss. This allowed an approximate reconstruction of the roof truss. This section was used as the main source to reconstruct the interior of the Synagogue.

There was a small room under the bima, which was probably used to store artifacts for the service. Under the platform of the Aron Ha-Kodesh, a geniza, a walled cavity, can be seen in the source. This was probably used to store old Torah scrolls. The geniza was not included in the reconstruction due to a lack of information.

Access to the synagogue was via the extension to the west. The women's prayer room was located on the upper floor.

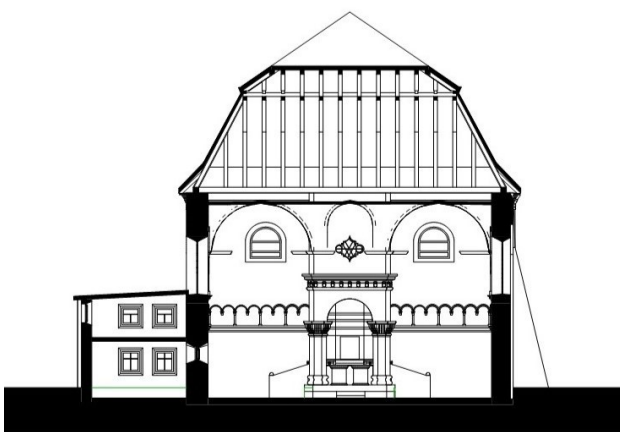
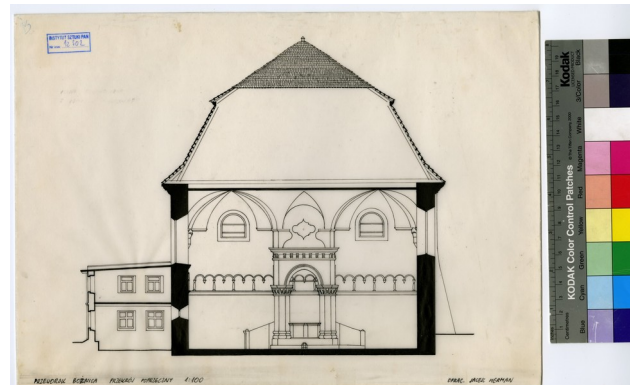
The section cuts through the synagogue to the west of the bima. The view is towards the east. The two-storey extension to the north with cheder and women's gallery can be seen.

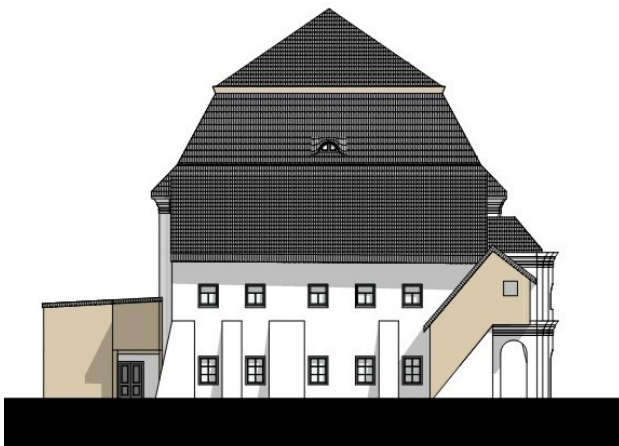
Fig. 75 Ansicht West

To the west is the annex through which the synagogue was entered. The area for the women in the upper part can be reached via a staircase. To the south of the extension was an opulent porch.

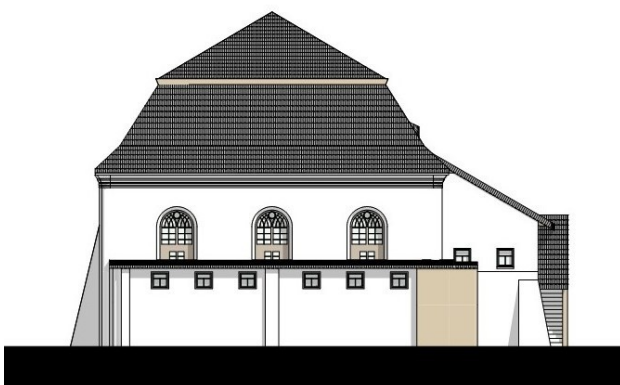
To the north was the two-storey extension with the cheder and a gallery for women. It was structured by pilaster strips and had 6 windows facing north on the upper floor.

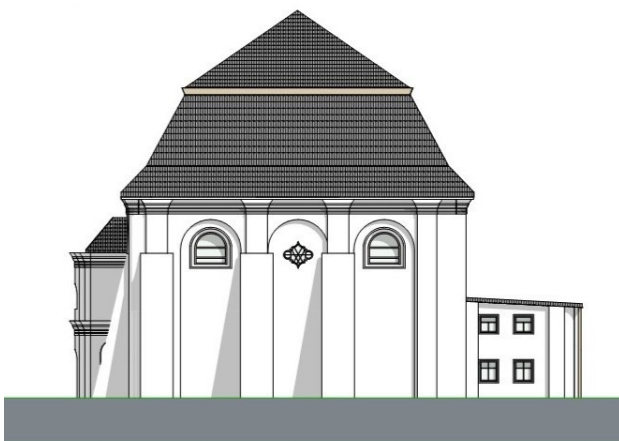
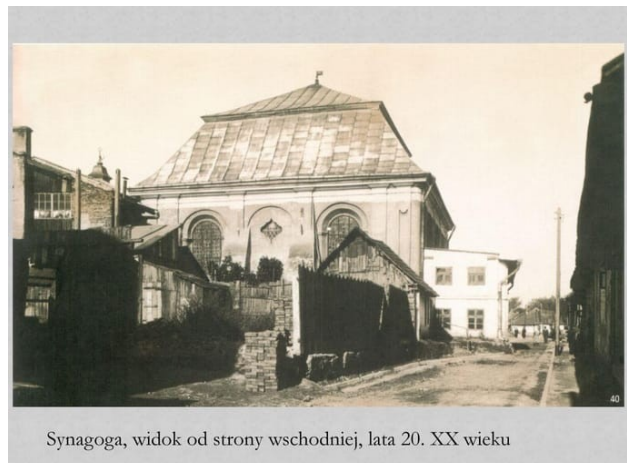
The east façade was divided into three parts by buttresses and pilaster strips. There was a special window in the middle above the Aron Ha-Kodesh. The east side of the extension had two windows on each floor.

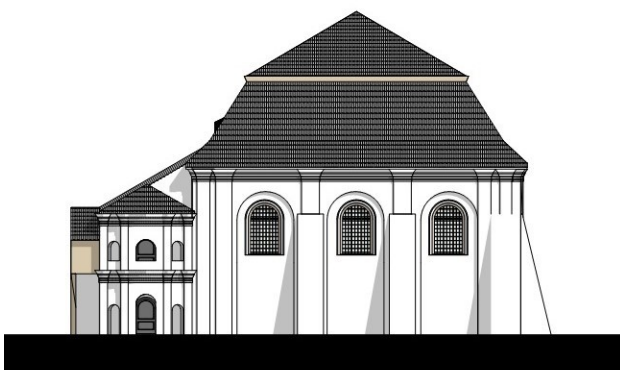
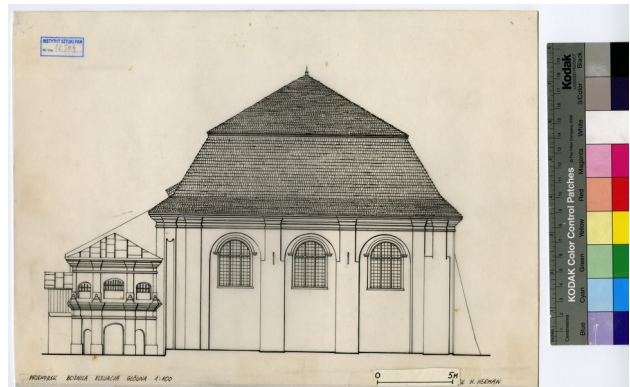
The main façade facing the street was the south façade. It was divided into three parts by buttresses and pilaster strips. The front part of the western extension consisted of a opulent two-storey porch, which was the main entrance to the synagogue. It is worth noting that the entrance to the vast majority of synagogues from this period was from the west.

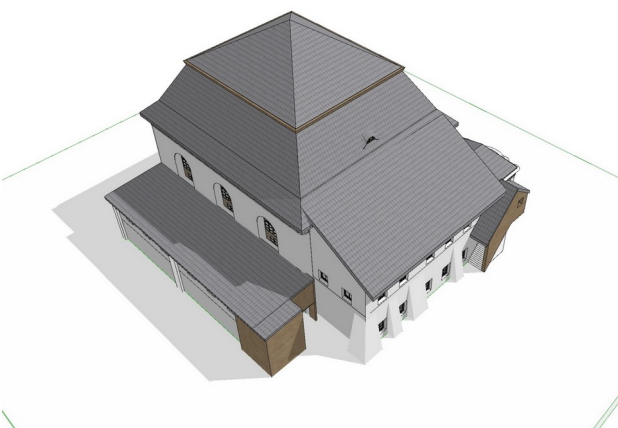
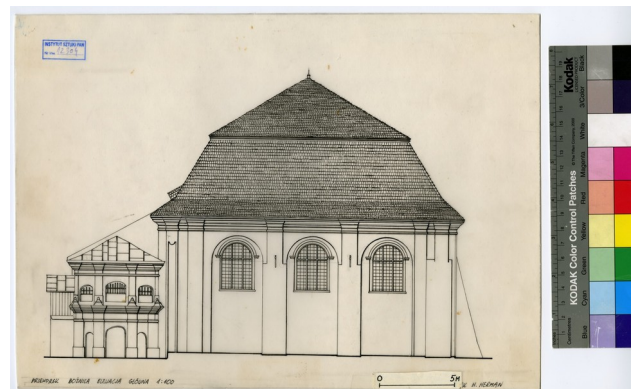
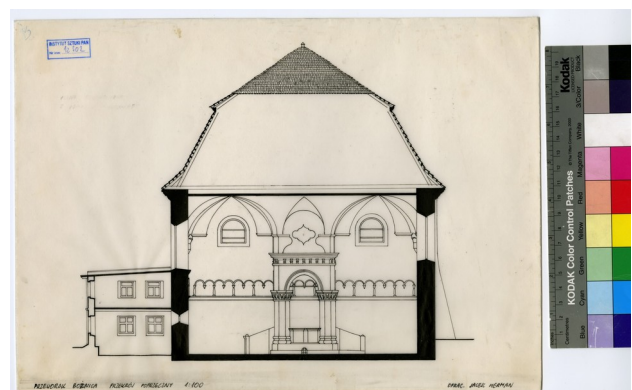
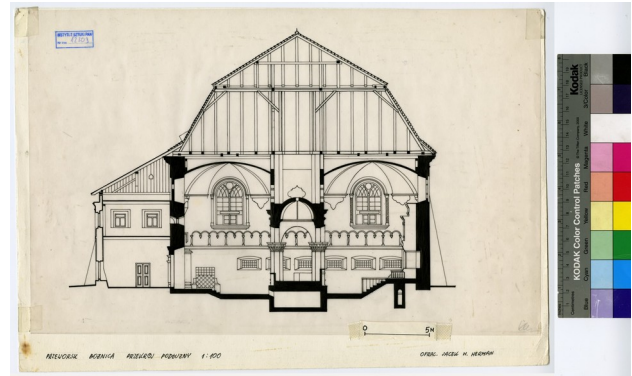
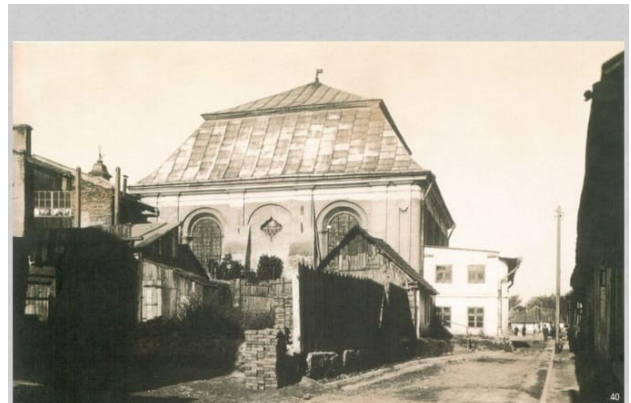
The wooden roof truss formed a mansard hipped roof. Originally it was probably covered with shingles, but in later depictions it appears to have been covered with some kind of metal. There was a skylight in the west.

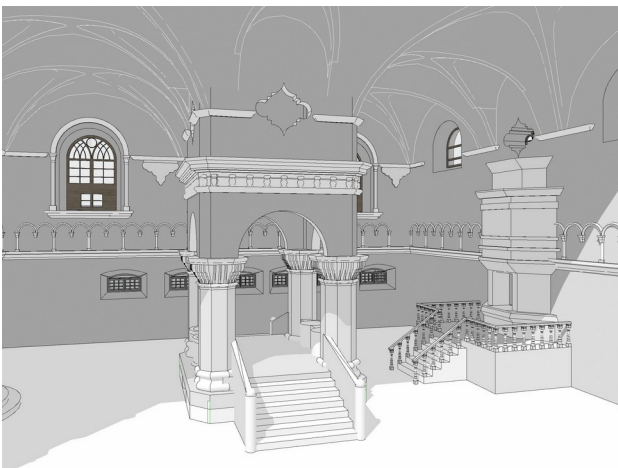
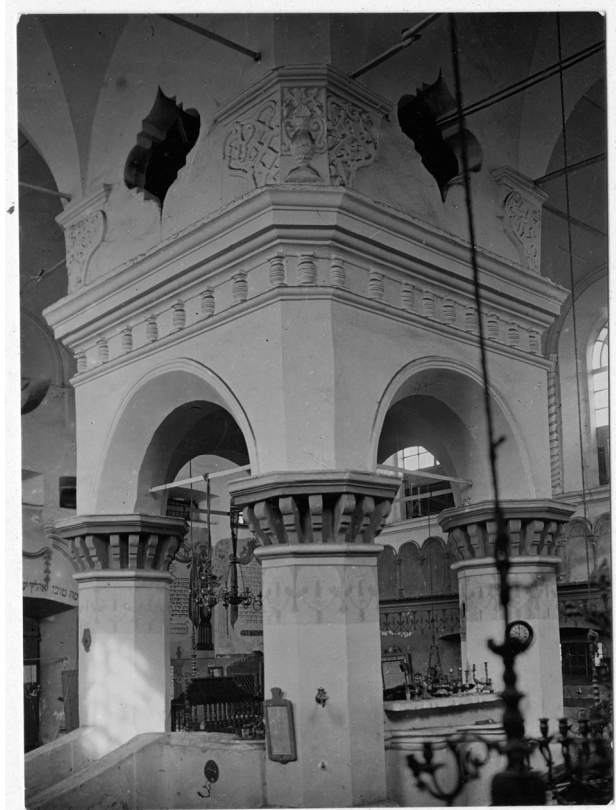
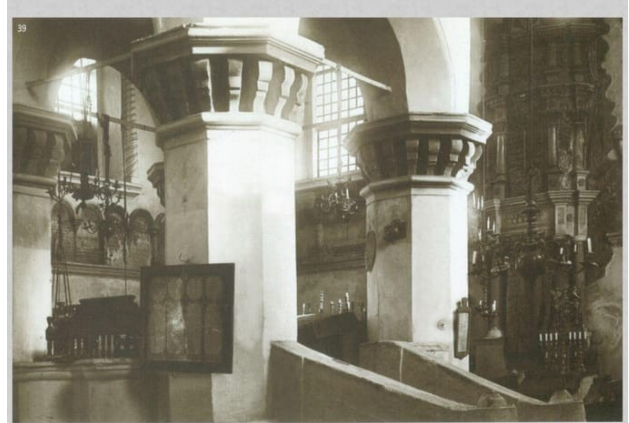
The prayer room was the main room of the synagogue with a height of around 10 meters. The vault rested on the outer walls and the bima in the middle of the room. It consisted of four pillars connected by round arches. The Aron Ha-Kodesch on the east wall can be seen in the photos and section.

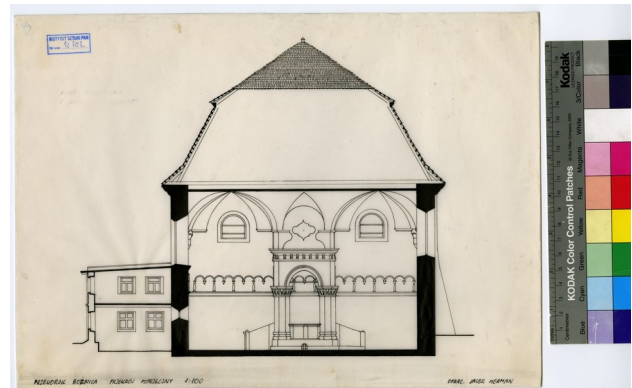
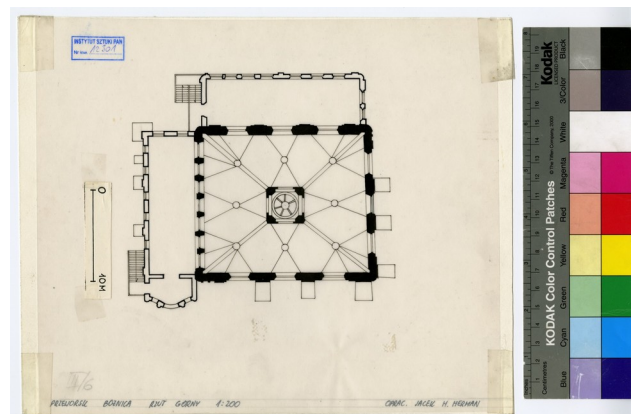
To the north was the two-storey extension to the synagogue from 1892, which housed the cheder. It was connected to the main prayer room, which was located approx. 1 meter below, by auditory windows. The upper part with the women's gallery was accessible via a staircase. It is not clear from the sources what the annex looked like from the inside and outside. It could therefore only be reconstructed using the information and depictions in the existing floor plans and elevations.

The interior appearance of the western extension with the entrance hall and another women's gallery on the upper floor is also largely unknown.

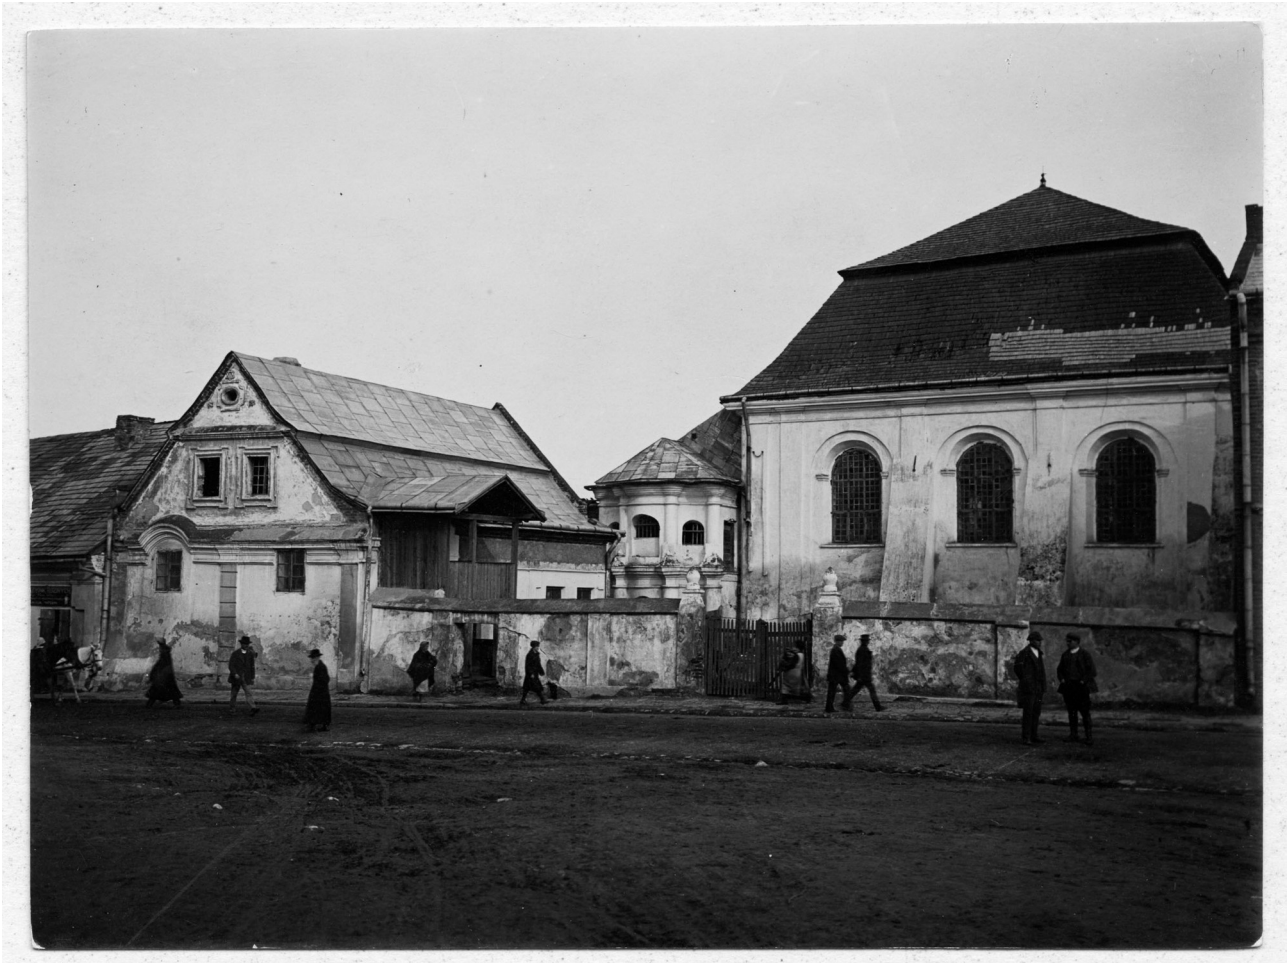
Type Photograph

Synagogue – Exterior – South façade

Fig. 27 Ansicht aus Südost

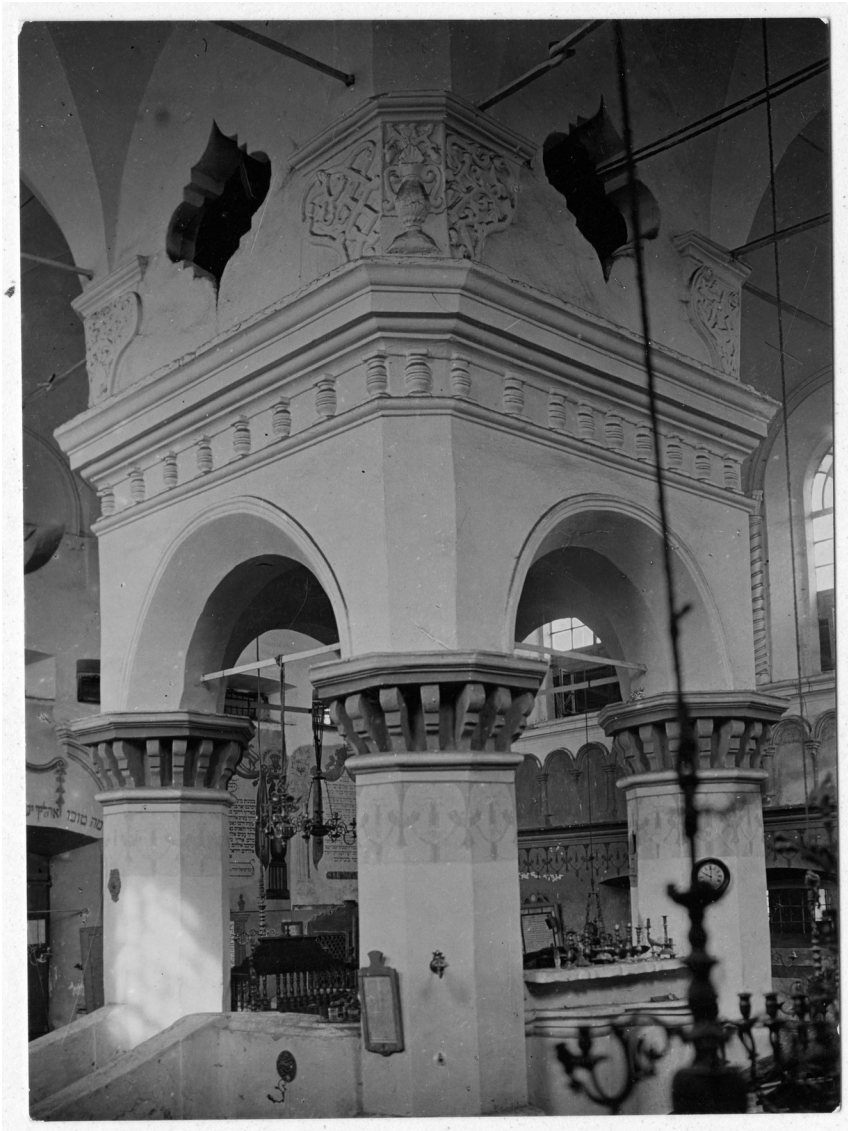
Type Photograph

Fig. 28 Bima und Innenraum

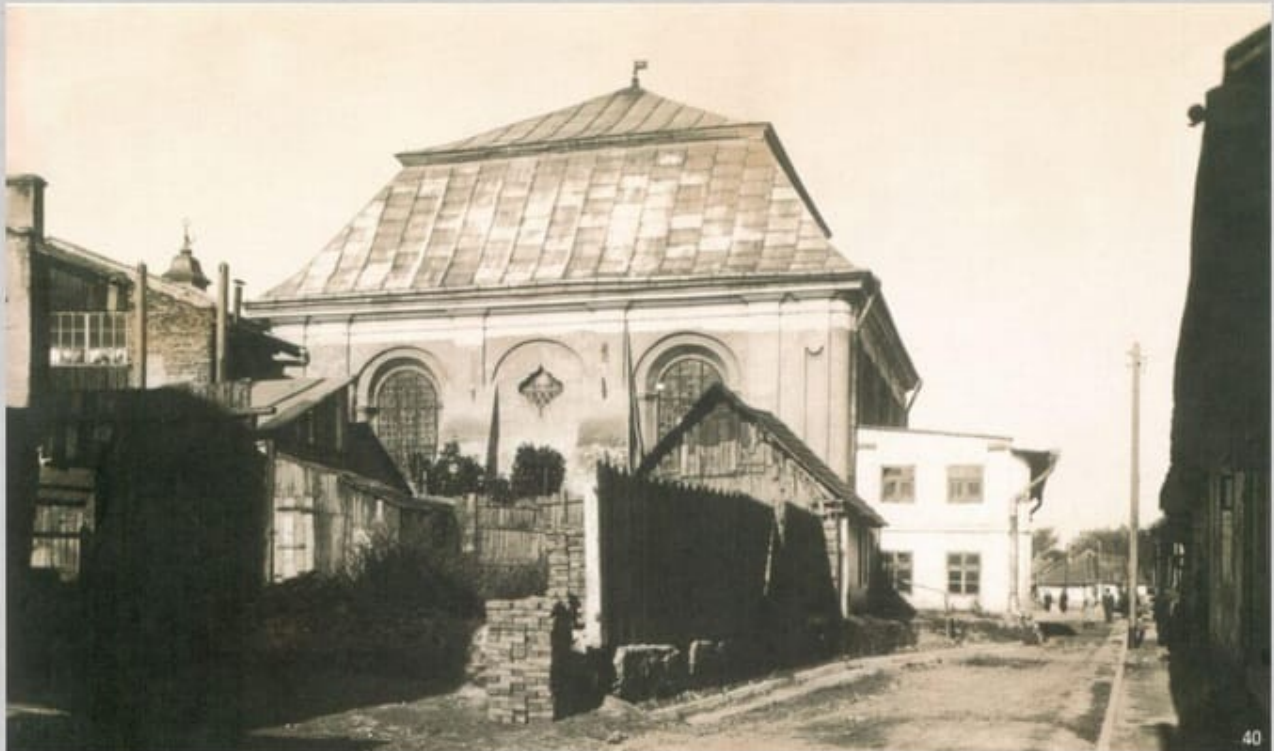
Synagoga, widok od strony wschodniej, lata 20. XX wieku

Type	Photograph	Used in:
Description	Auszug aus der Broschüre über das Tagebuch von Basi Rosenberg	Synagogue – Exterior – East façade Synagogue – Exterior – Roof
Author	Basi Rosenberg	
Archive		
Signature		
Copyright

Fig. 33 Fotografie Ostfassade

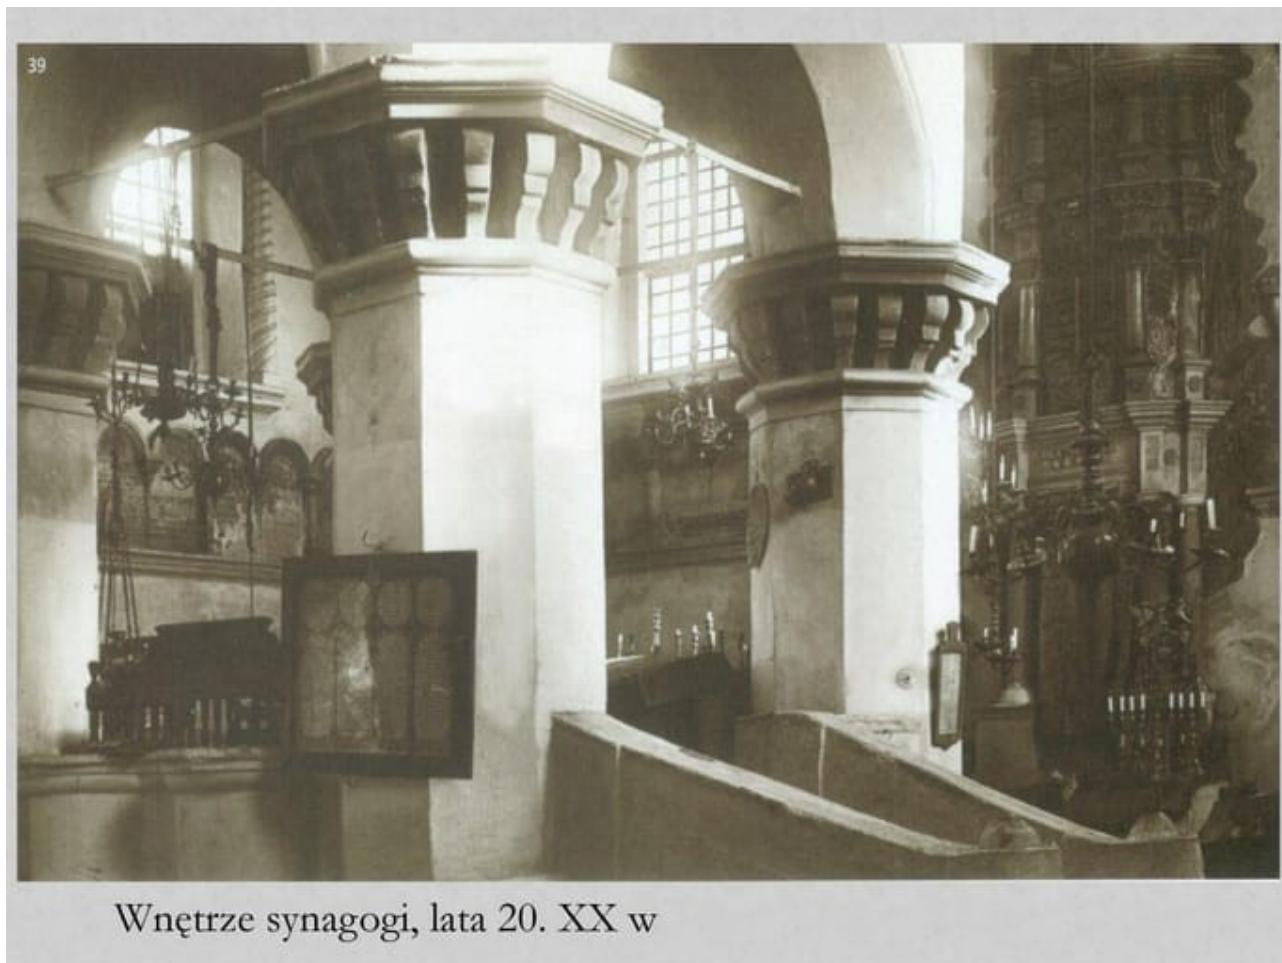
Type	Photograph	Used in:
Description	Auszug aus der Broschüre über das Tagebuch von Basi Rosenberg	Synagogue – Interior – Prayer room
Author	Basi Rosenberg	
Archive		
Signature		
Copyright

Fig. 34 Fotografie Gebetsraum
