Window_a		
Reconstruction

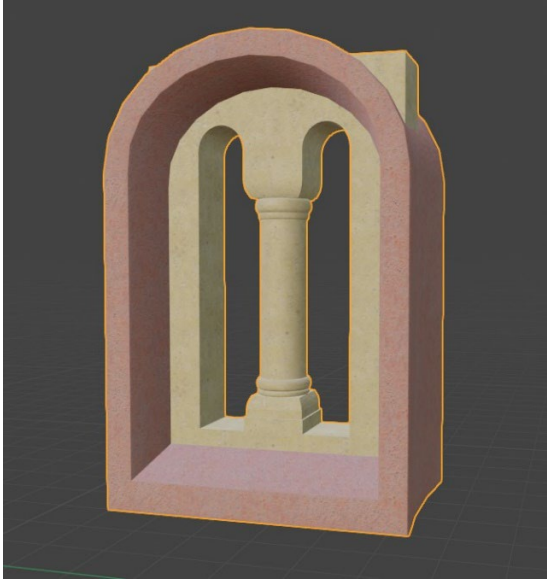
Uncertainty	The windows on the western façade are still existing (now in museum) and are therefore level 4. The windows of the eastern wall were reconstructed based on the windows from the museum.	Windows West wall: Level 4 Windows East wall: Level 3
Argumentation	On the basis of the museum photo, a simple cube was used in combination with two cylinders as Booleans to create the bifocal shape of the window. The dimensions were taken from the report text page 11 by Georg Litzel. The column of the window was added as an extra cylinder mesh, while the upper and lower parts of the columns were built from the leftovers of the Boolean in the cube.

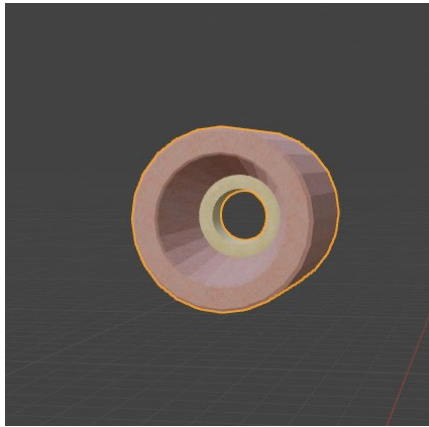
Window_b		
Reconstruction

Uncertainty	As there are still windows visible in each wall, the level of uncertainty is 4 = still existing	Level 4
Argumentation	<p>The report drawing was taken as the basis for the reconstruction and dimension of the window, while the photo was used to see how deep the windows were set into the wall. The dimensions were compared to the report text page 11 by Georg Litzel. The windows were reconstructed with a cylinder, that was solidified and a cylinder as a Boolean.</p>

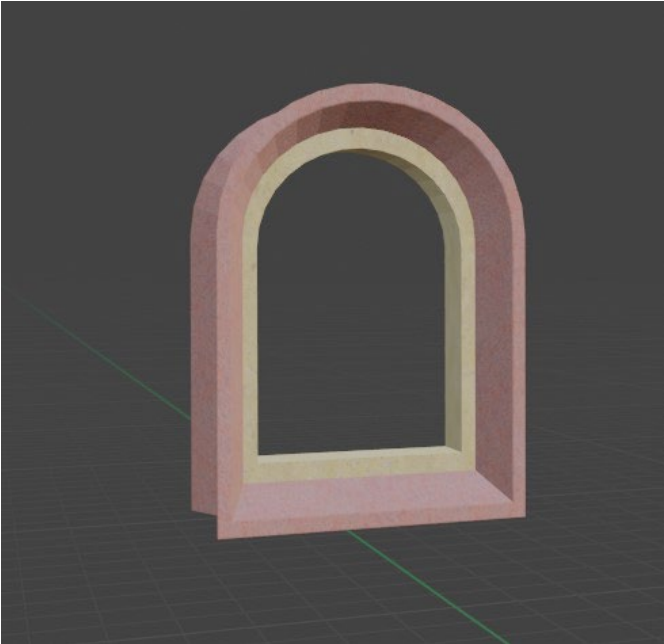
Window_c		
Reconstruction

Uncertainty	The windows don't exist any more and there are no visible markings in the walls to reconstruct the placement or dimensions of the windows.	Level 2
Argumentation	The dimensions, structure and placement were taken from the report text page 11 by Georg Litzel. The windows were reconstructed with a cylinder, which was cut in half and solidified, this was then copied and used as a Boolean.

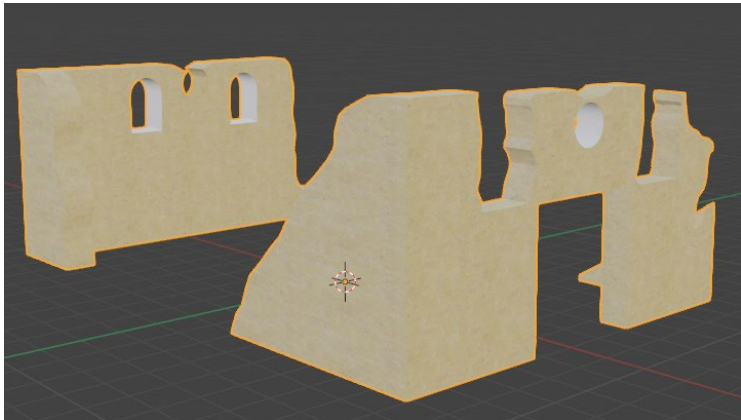
Wall_a		
Reconstruction

Uncertainty	These wall are still existing and were examined and dated to specific time periods	Level 4
Argumentation	The dimensions of the wall were taken from report_drawing_03 and 05, with the difference to the reconstructed walls taken from the photographs.

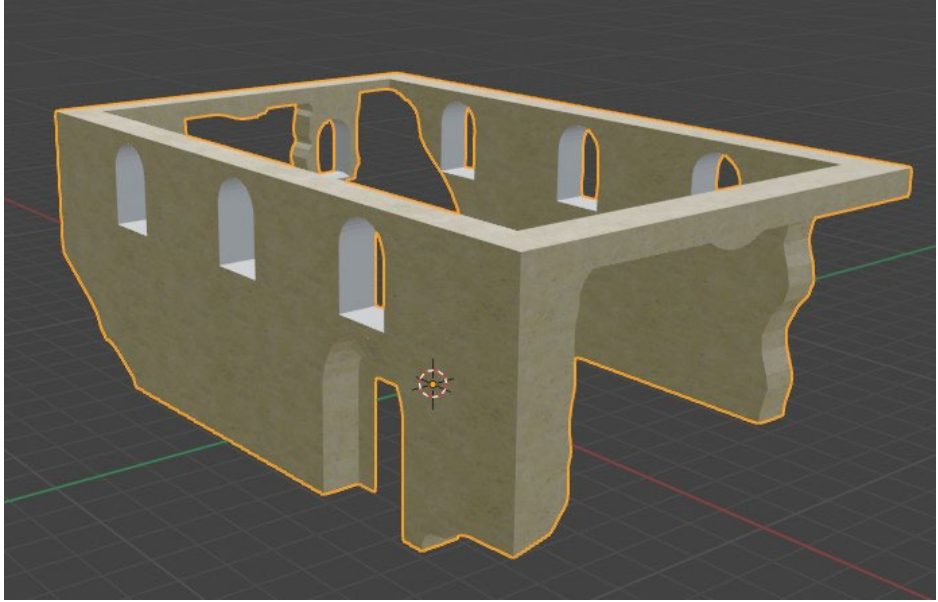
Wall_b		
Reconstruction

Uncertainty	These walls were reconstructed based on the missing areas between the ruins of the walls, that can be still seen today.	Level 3
Argumentation	<p>The dimensions of the wall were taken from report_drawing_03 and 05, with the difference to the reconstructed walls taken from the photographs. The walls were first created from a cube, with a different cube as a Boolean and then cut with the Knife tool to separate the still existing wall (a) and the reconstructed wall (b).</p>

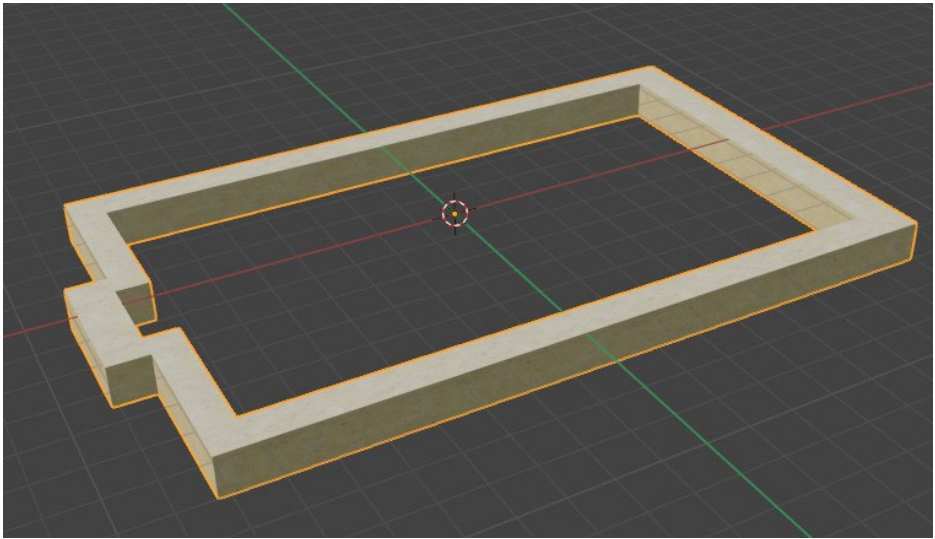
Foundation		
Reconstruction

Uncertainty	The foundation can still be found today and was examined in the archaeological excavation.	Level 4
Argumentation	The dimensions were taken from the report_drawing_03 and the height was defined at 1 Meter.

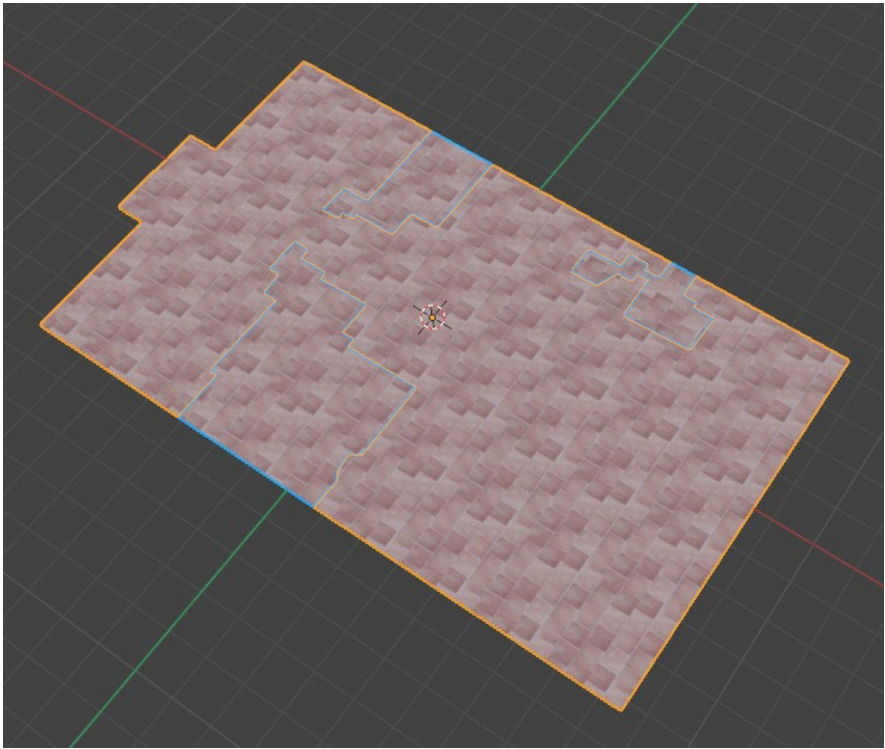
Floor		
Reconstruction

Uncertainty	In the report drawing some of the floor parts are marked as still existing (level 4), the rest was deducted (level 3)	Level 4 Level 3
Argumentation	The floor was reconstructed with the report drawing as a basis. First a cube was modelled to fit the dimensions of the synagogue, with the Knife tool the still existing floor part were cut out and then separated.

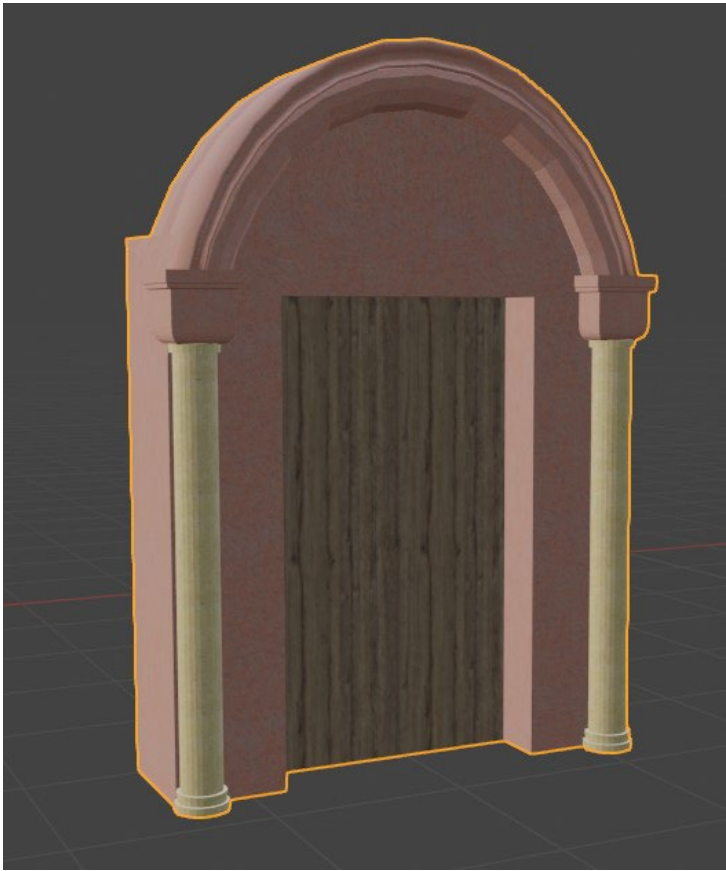
Doorway		
Reconstruction

Uncertainty	There is not much left of the doorway, so the doorway of analogy_02 was used	Level 2
Argumentation	<p>The basic structure of analogy_02 was used to recreate and reconstruct the doorway of the synagogue. The width was taken from the report_drawing_03. The doorway was modelled by combining cubes and cylinders and using Booleans to create the opening for the door.</p>

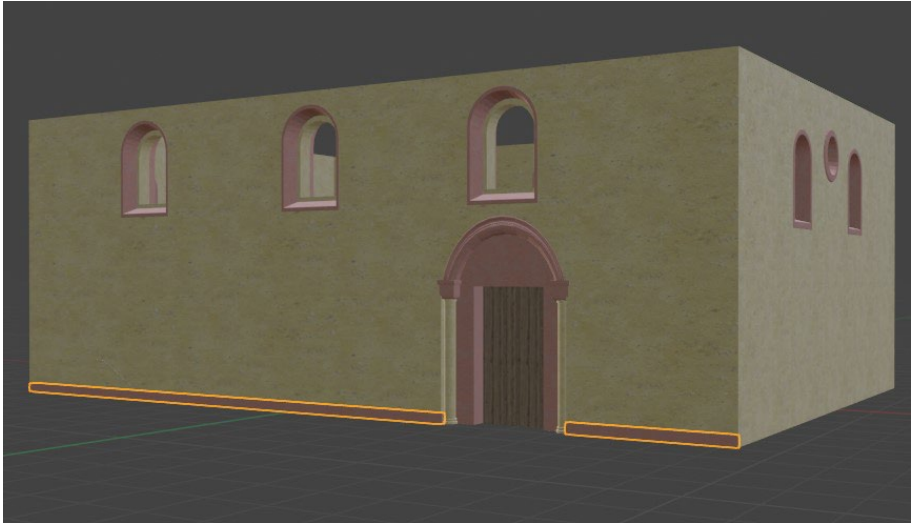
Plinth		
Reconstruction

Uncertainty	There are no definitive images of the plinth, but in the archaeological report it is mentioned, that the plinth was found in the excavation	Level 4
Argumentation	Based on the archaeological report the plinth was added with a simple cube, fitting with the dimensions of the northern façade.

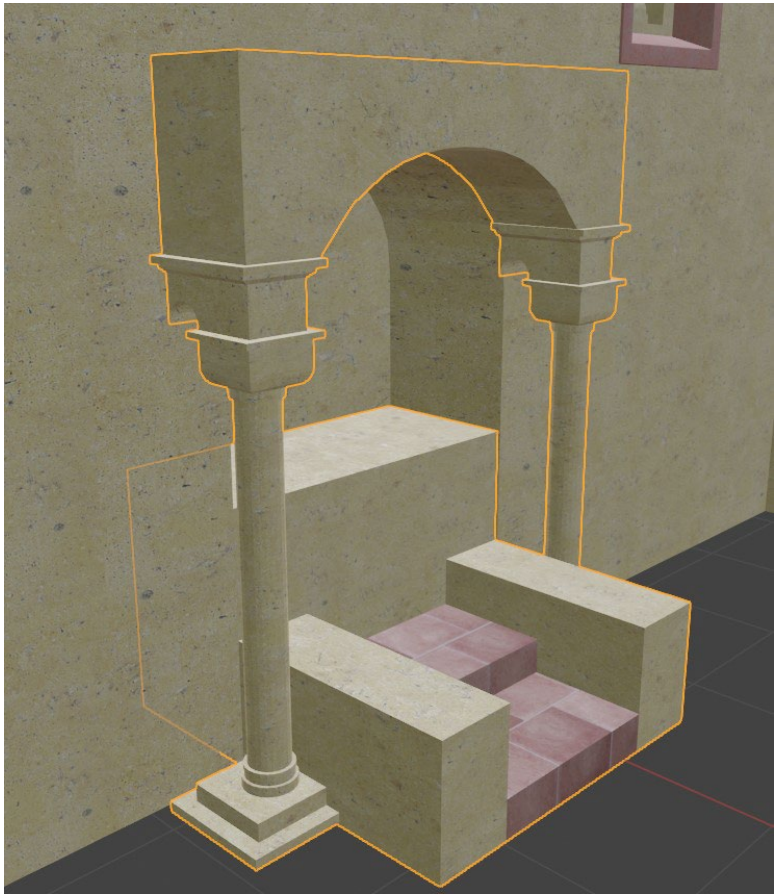
Aron HaKodesh		
Reconstruction

Uncertainty	There is not much left of the Aron Hakodesh, which led to the use of analogies, mainly the text and images from article-01	Level 2
Argumentation	<p>The reconstruction was mainly based on article_01 and modelled to fit with the rest of the Aron Hakodesh, which was visible in the eastern wall. The reconstruction was created with cubes, cylinders and Booleans, which were modelled to fit the overall look found in article_01.</p>

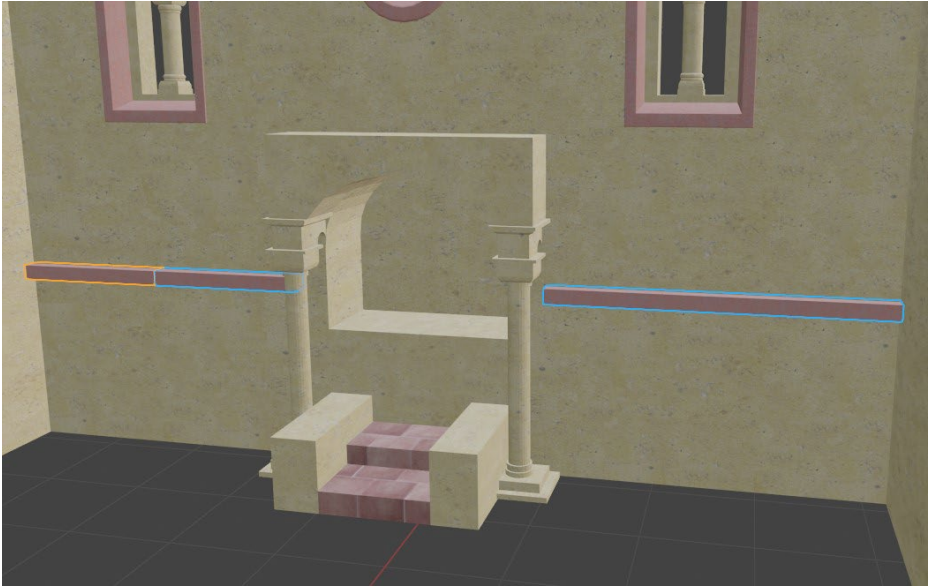
Cornice		
Reconstruction

Uncertainty	There are still parts of the cornice visible (level 4) the rest of the cornice was reconstructed (level 3)	Level 4 Level 3
Argumentation	The drawing of the inner wall was mainly used to reconstruct the cornice and model the missing parts. A cube was used to build the cornice, which was then separated to the still existing and the reconstructed parts.

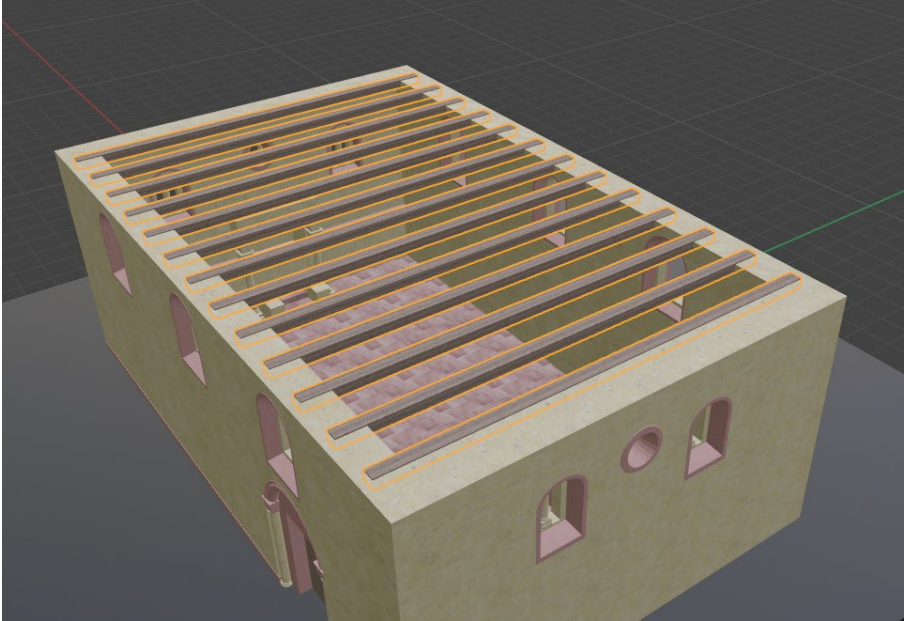
Beams_c		
Reconstruction

Uncertainty	The beams and roof of the synagogue don't exist anymore, there are no fitting analogy to use for the reconstruction	Level 1
Argumentation	<p>Without any analogies or similar structures, the beams were modelled after the architectural basics of the type of roof, that was defined for the synagogue. The beams were reconstructed from cubes, which were multiplied with the Array modifier.</p>

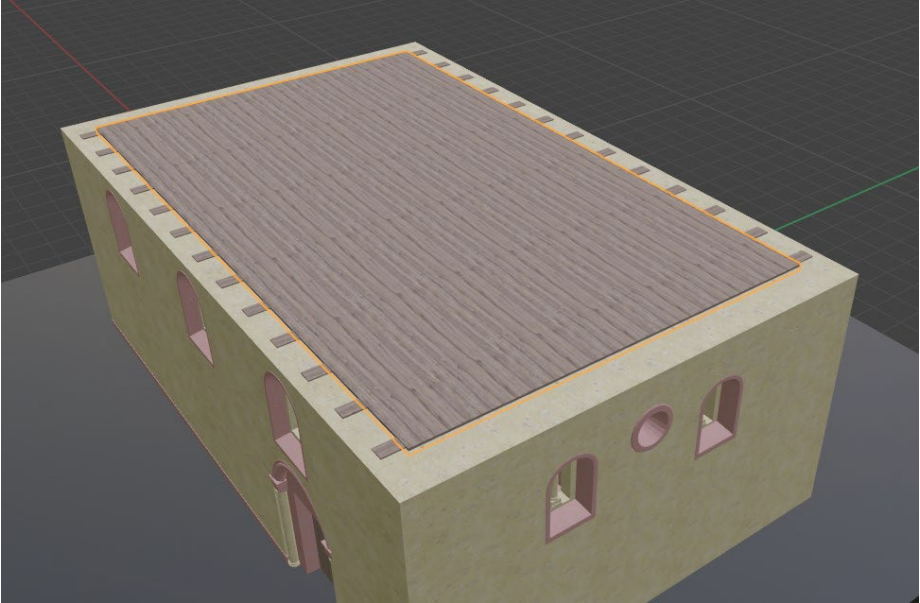
Ceiling		
Reconstruction

Used sources	There are no sources	
Uncertainty	The beams and roof of the synagogue don't exist anymore, and there is no source for a ceiling between the beams for the roof	Level 1
Argumentation	A ceiling was added, which is also the floor of the attic. It was modelled from a cube and set on top of the beams c.

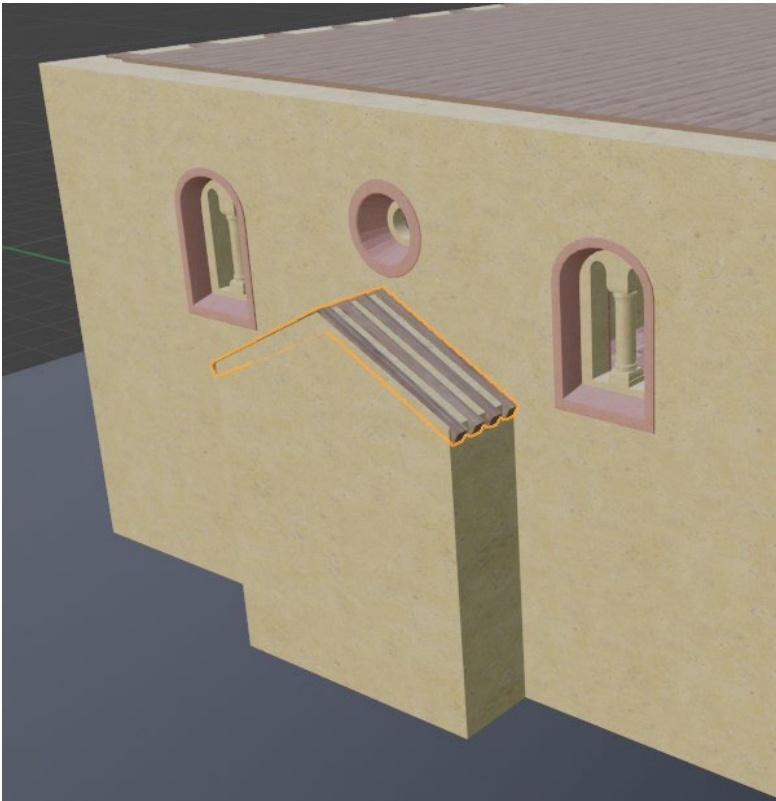
Beams_b		
Reconstruction

Uncertainty	The beams and roof of the synagogue don't exist anymore, there are no fitting analogy to use for the reconstruction	Level 1
Argumentation	<p>Without any analogies or similar structures, the beams were modelled after the architectural basics of the type of roof, that was defined for the synagogue. The beams were reconstructed from cubes, which were multiplied with the Array modifier.</p>

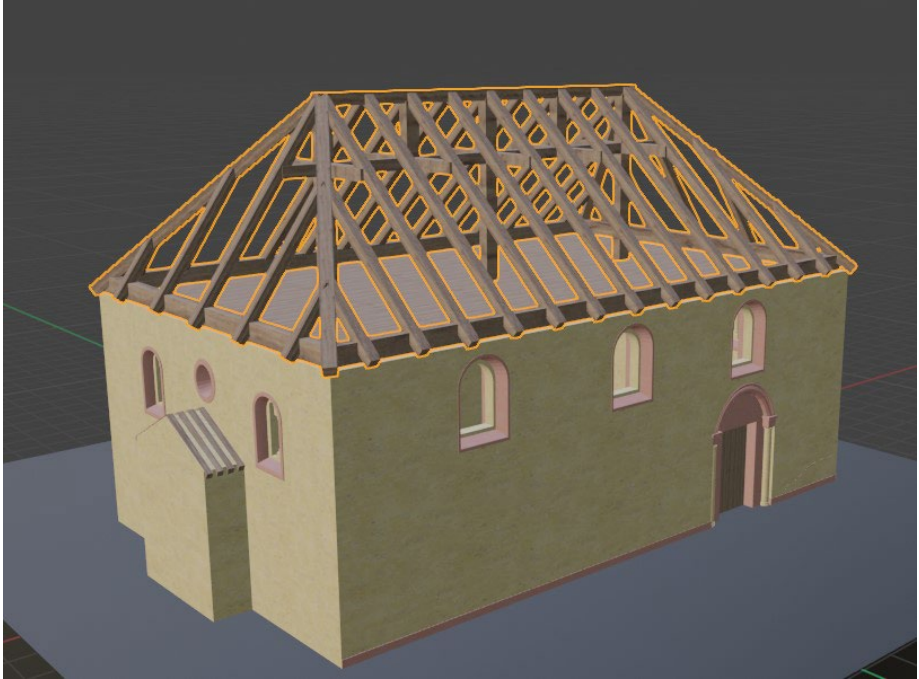
Beams_a		
Reconstruction

Uncertainty	The beams and roof of the synagogue don't exist anymore, there are no fitting analogy to use for the reconstruction	Level 1
Argumentation	<p>Without any analogies or similar structures, the beams were modelled after the architectural basics of the type of roof, that was defined for the synagogue. The beams were reconstructed from cubes, which were multiplied with the Array modifier.</p>

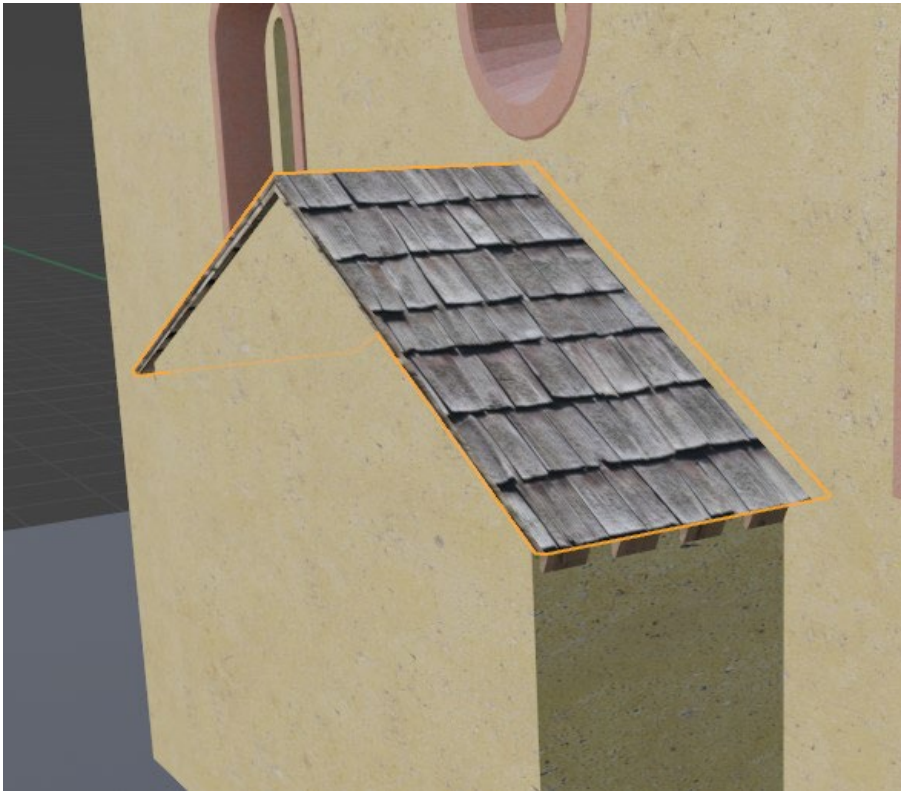
Roof_b		
Reconstruction

Uncertainty	The beams and roof of the synagogue don't exist anymore, there are no fitting analogy to use for the reconstruction	Level 1
Argumentation	Without any analogies or similar structures, the roof was modelled to fit the structure of the beams.

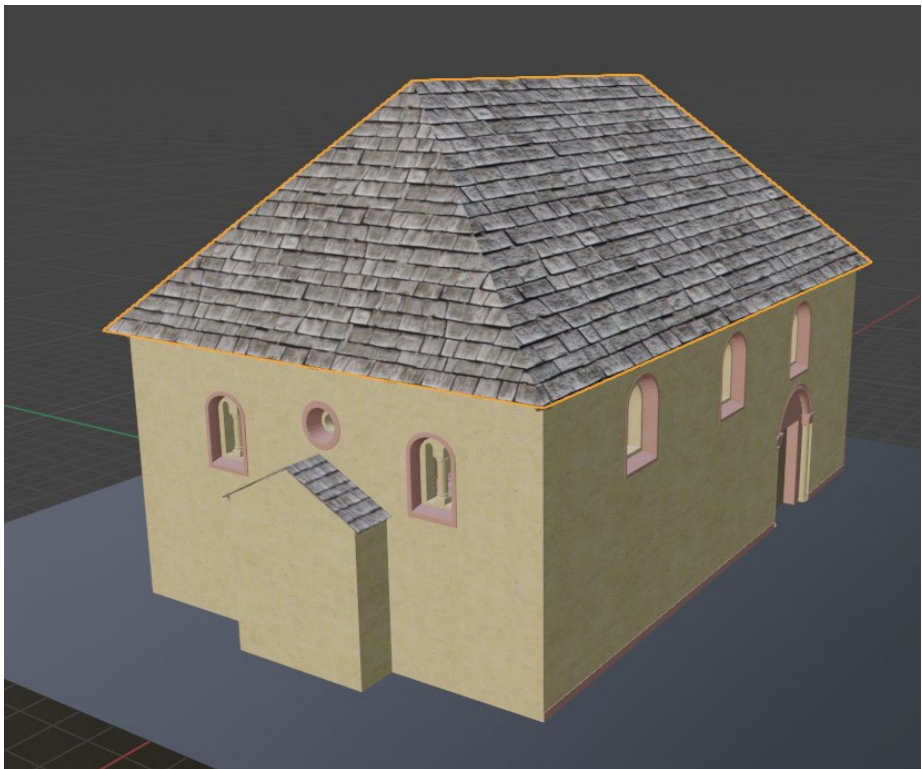
Roof_a		
Reconstruction

Uncertainty	The beams and roof of the synagogue don't exist anymore, there are no fitting analogy to use for the reconstruction	Level 1
Argumentation	Without any analogies or similar structures, the roof was modelled to fit the structure of the beams.
